Technical Report 03-1
Bridge Deck Resurfacing using Rosphalt 50

Construction Report - January 2003

Bridge Deck Resurfacing using Rosphalt 50

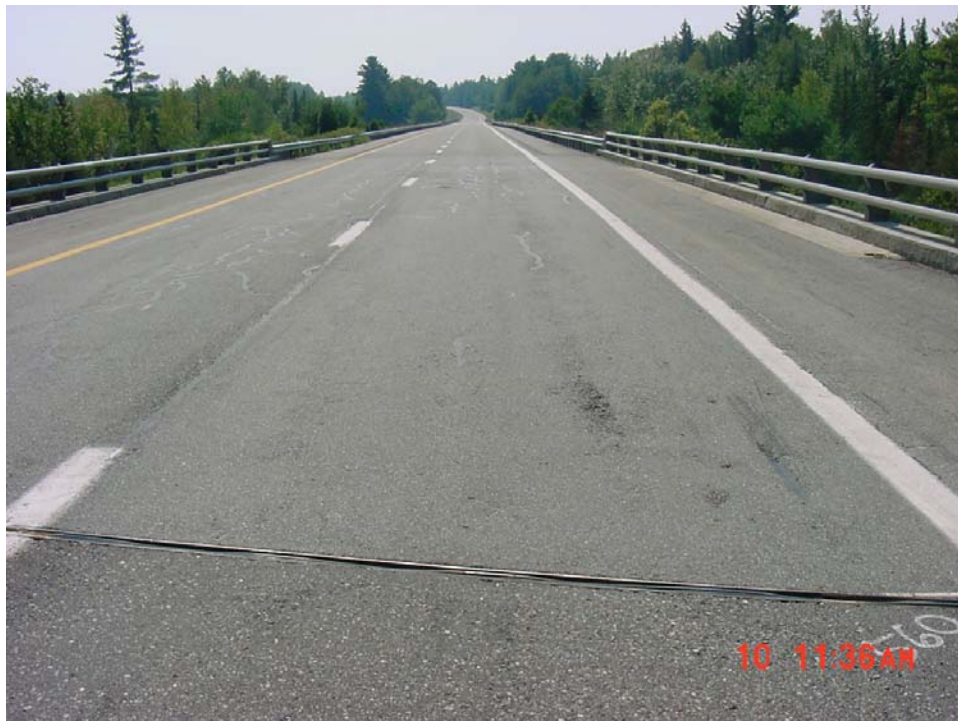
Photo 1. Bridge #6070 wearing surface

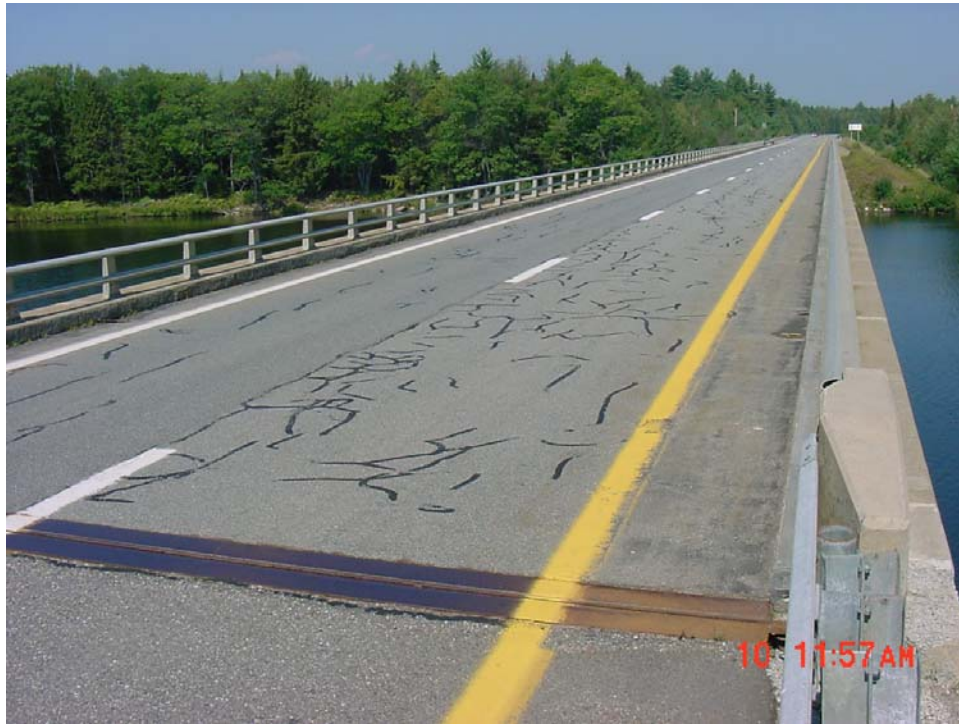
Photo 2. Bridge #6069 wearing surface

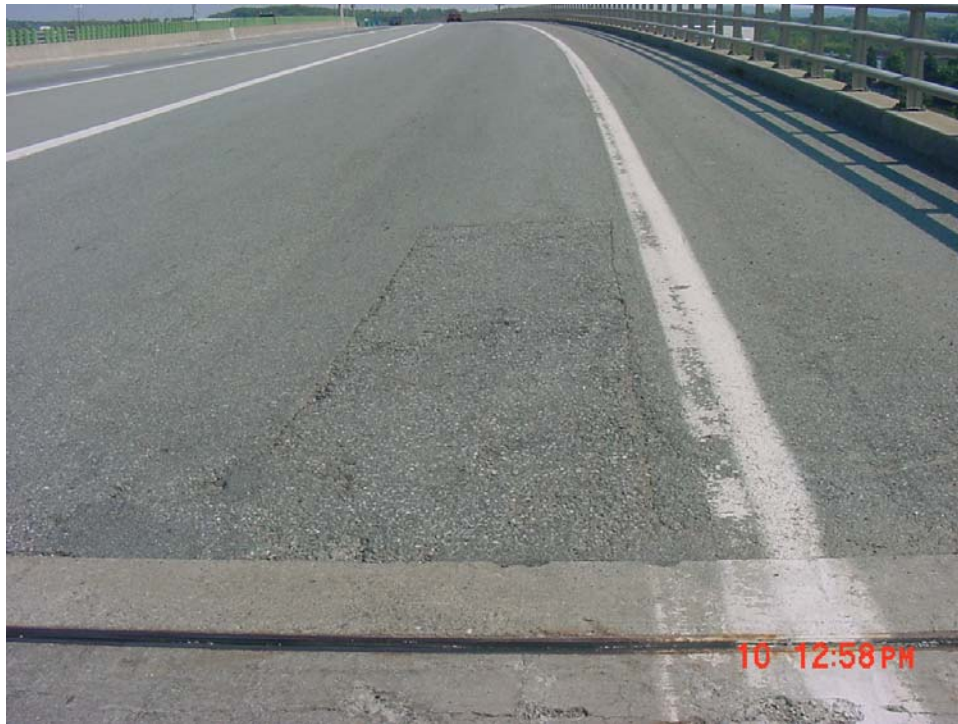
Although the wearing surface was in fair condition, there were areas of shoving that have been repaired over the past five years (Photos 3 & 4). The problem areas are located on the accelerating lane of each entrance ramp and decelerating lane of each exit ramp.

Photo 3. Bridge # 1558 patch area on entrance ramp

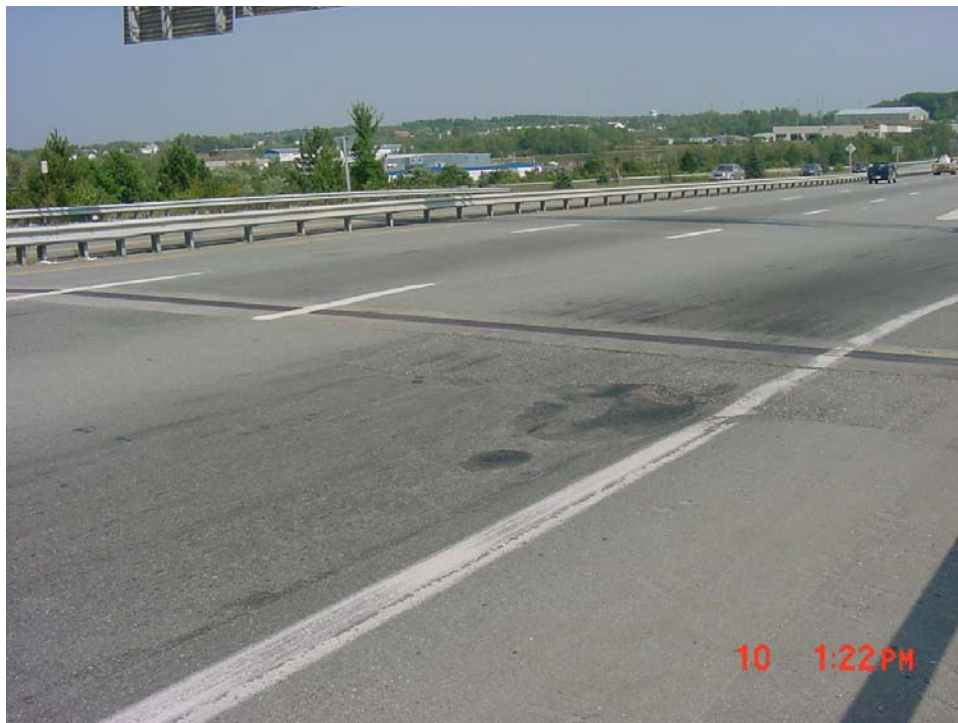
Photo 4. Bridge # 1558 patch area on exit ramp

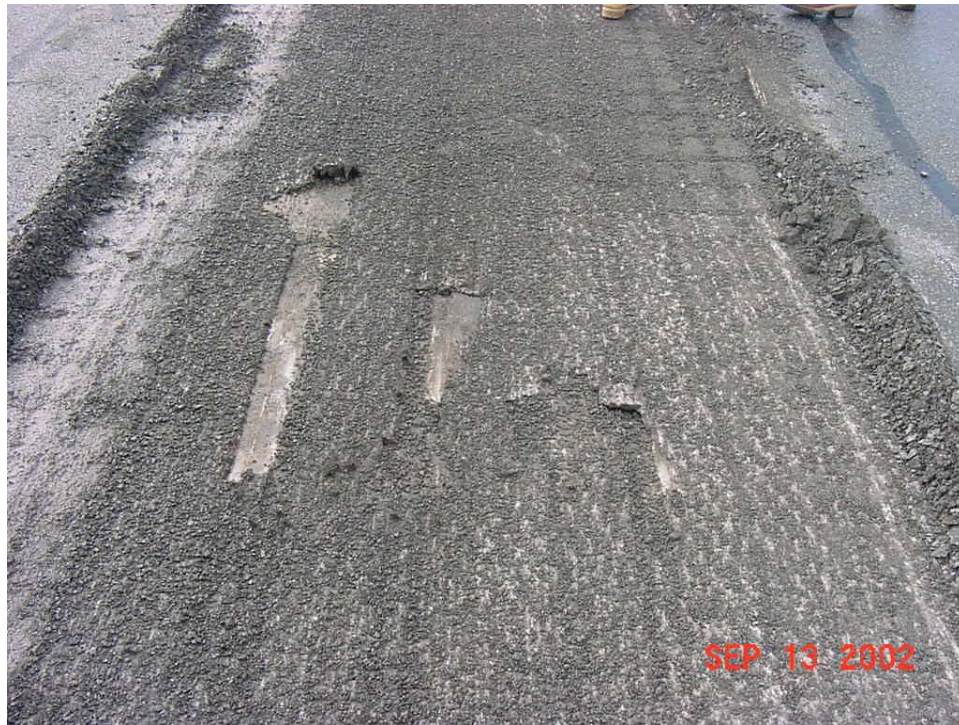
While milling an area of bridge # 6069, the deck membrane was corrupted (Photo 5). The milling machine was raised 6 mm (0.25 in) to avoid disturbing the remaining waterproof membrane. Prior to construction, MDOT Bridge Maintenance Division was asked to replace joint seals and repair areas with deteriorated PCC bridge deck or waterproof membrane after the bridge decks were milled. When notified of the membrane damage, Bridge Maintenance had to send for patch material, which would take one or two days to deliver and an additional one or two days to repair. Due to the limited number of construction days and the fact that Rosphalt 50 enhanced bituminous material seals bridge decks, a decision was made

Photo 5. Damaged membrane on bridge # 6069

to cut away loose membrane material from the deck and the exposed bridge deck would then be sealed when resurfaced with Rosphalt 50. After the travel lane was milled, the surface was brushed clean and allowed to dry. Royston Edge Sealer 120-29 was applied on all vertical surfaces (Photo 6) and the deck was tack coated with Royston 754 Tac-Coat (Photo 7) and allowed to cure overnight.

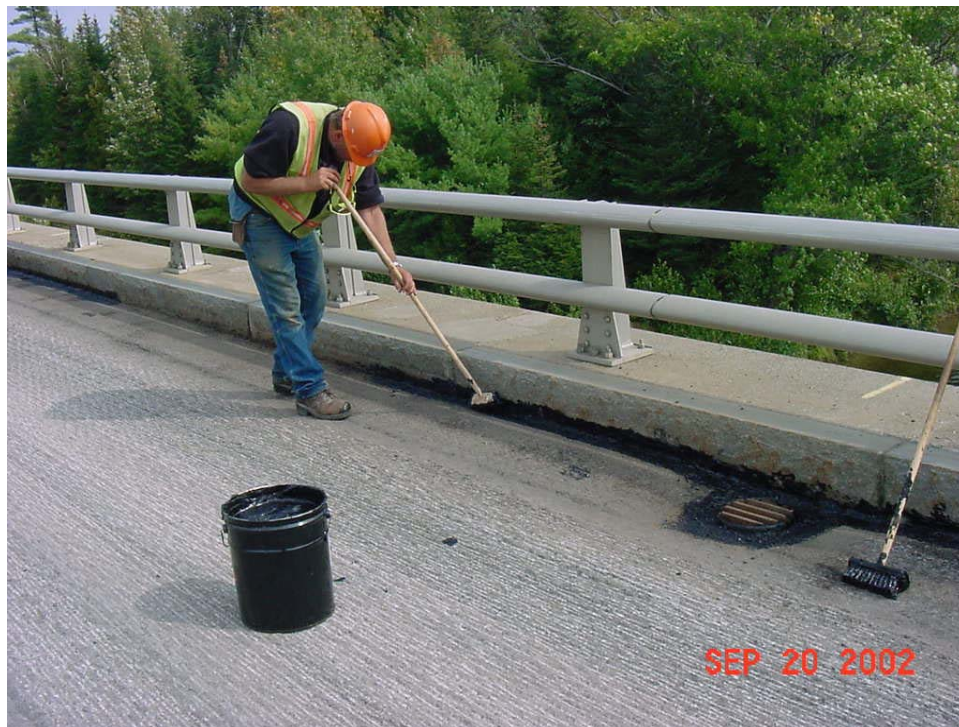
Photo 6. Royston 120-29 Edge Sealer

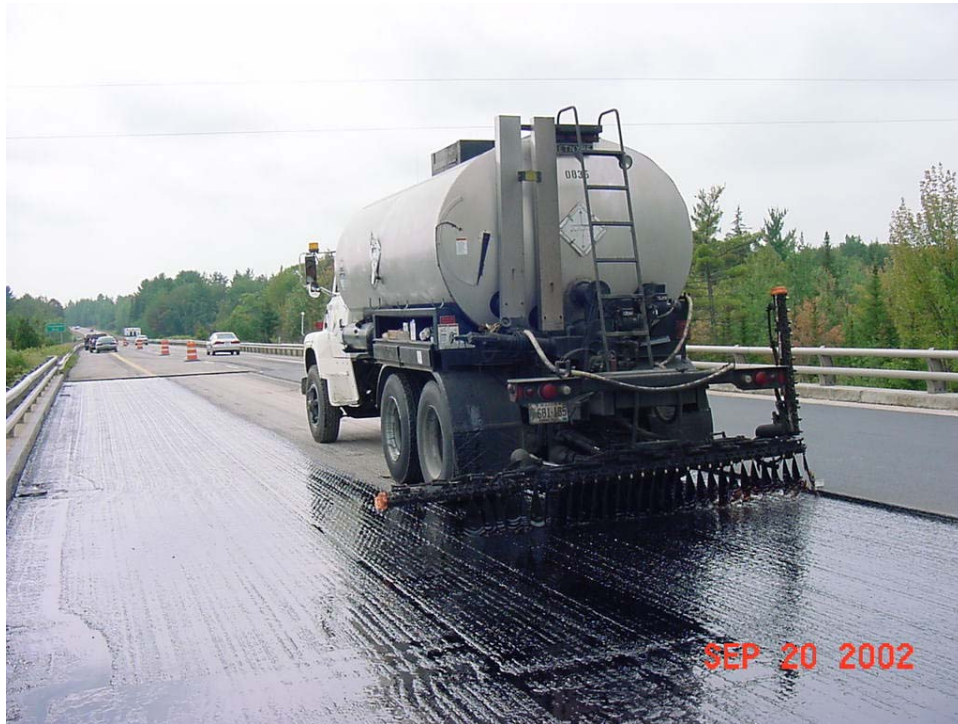
Photo 7. Royston 754 Tac-Coat

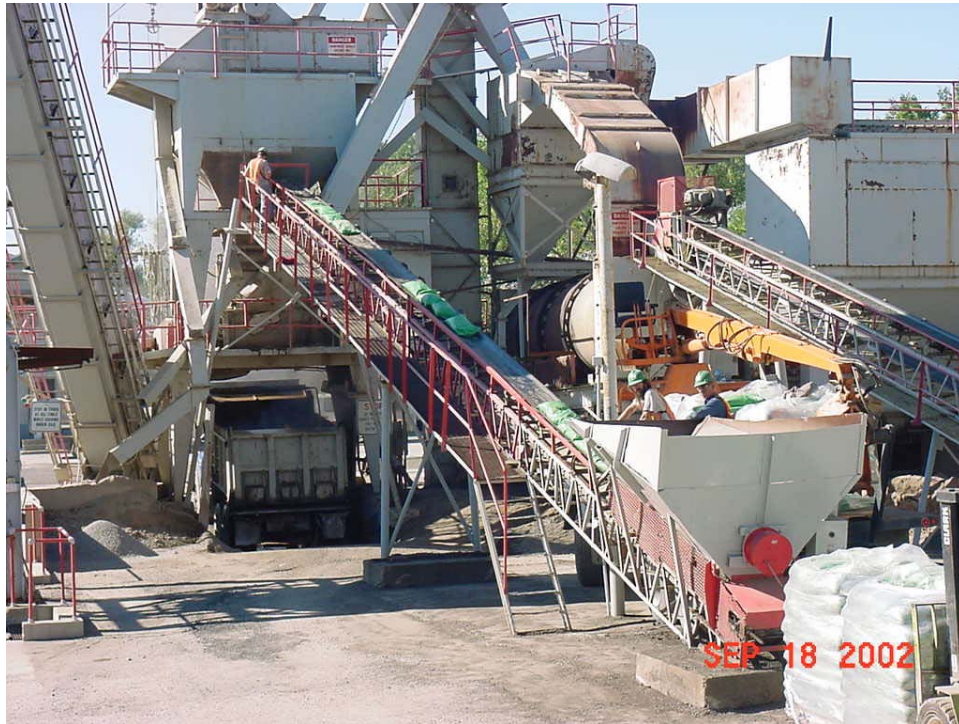
Manually feeding the bags was not an option and the plant was shut down for modifications to the pug mill access hatch. After the modification, a second wet trial batch was attempted and the bags of Rosphalt 50 fed properly. The second wet trial batch temperature was 238° C (460° F). Although the temperature was higher than specifications allowed, Royston representatives accepted the load and sent it to the project. Second and third truckloads of material had temperatures of 227 and 233° C (441 and 452° F) respectively.

Photo 8. Feeding Rosphalt 50 into the pug mill

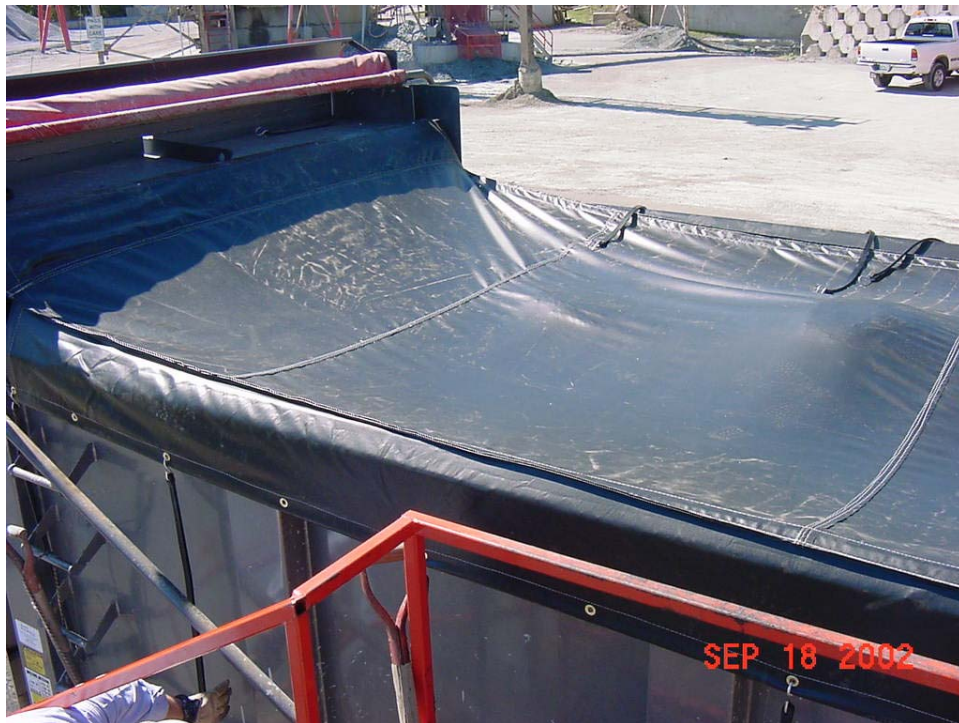
Distance between plant and project was 58 km (36 mi) and it took approximately one hour to deliver each load of bituminous material. Royston was adamant about covering the load to prevent material cooling while in transit. Covers were specifically made for each truck to completely cover the load (Photo 9). The covers worked very well at keeping mix temperatures from dropping. Day one average plant temperature

Photo 9. Truck bed cover

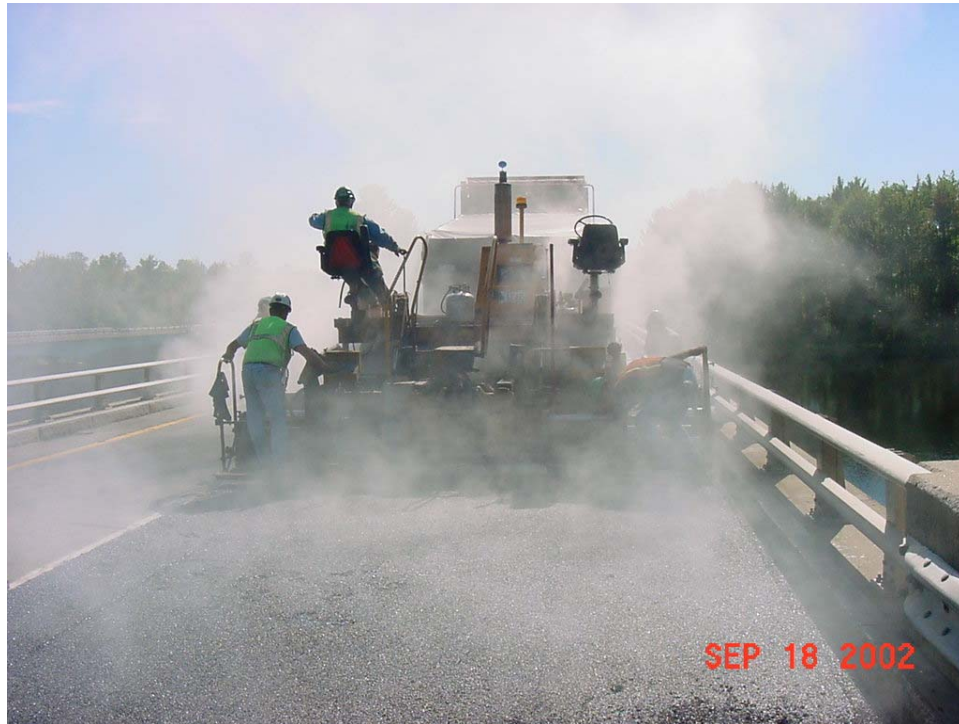
Paving went smoothly and Royston monitored placement and compaction very closely. One concern was the amount of smoke generated from the hot mix being placed on the bridge deck (Photo 10) causing a potentially hazardous traffic safety problem that could not be avoided. Workers around the paver were advised to be cautious. Lane Construction used three trucks to deliver material. This caused delay between loads that cooled material in the paver to levels below lay down specification. MDOT personnel requested another truck be outfitted with a cover to deliver material and reduce the amount of delay. As paving proceeded, bridge drain covers were removed and material around them was hand compacted. Breakdown roller lines were smoothed with the finish roller leaving a very smooth mat.

Photo 10. Poor visibility

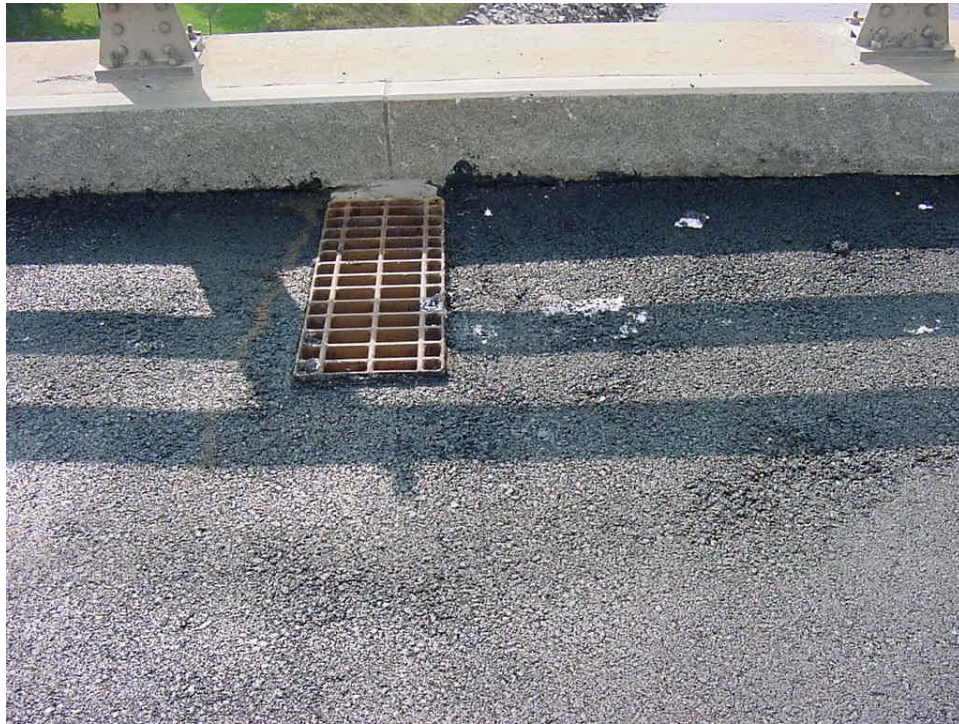
Photo 11. Poor compaction around drains.

Placing the second lift of Rosphalt 50 went smoother than the first, but there were problems. Balls of material were noticed in the mat on this lift also. Prior to placing the second lift around the drains, hot mix was hand placed and compacted around drains that appeared to have poor compaction. Hand compaction of the second lift around drains had improved.

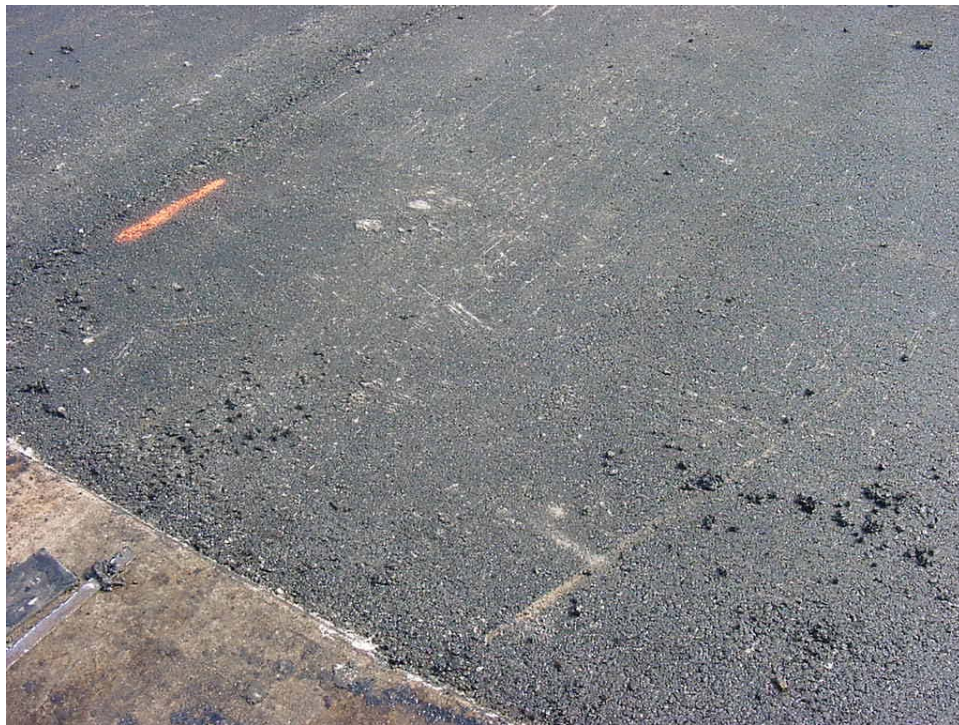
cold mix at the start of the next lane. This resulted in a mat that looked very coarse (Photo 12). This continued until hot mix was reintroduced to the screed. Rosebud torches were used on the mat in these areas to increase mix temperature and improve compaction.

Photo 12. Cold mix at beginning of lane.

1. Due to sensitivity of the mix being over compacted and possibly tearing, the knockdown roller was reduced in size from a 10 ton to an 8 ton machine.
2. Requesting Lane Construction follow pre-construction guidelines to keep a full head of material in front of the screed when approaching a butt joint.
3. Royston and MDOT thermometers will be checked for accuracy and that plant and lay down temperature specifications will be followed.
4. More attention will be given to drain areas to increase density of material.
5. Addressed trucks waiting to be unloaded and the mix cooling down, trucks will be spaced evenly to reduce this problem.
6. Lane Construction agreed to periodically empty the paver hopper to eliminate balls of cold material on the mat.

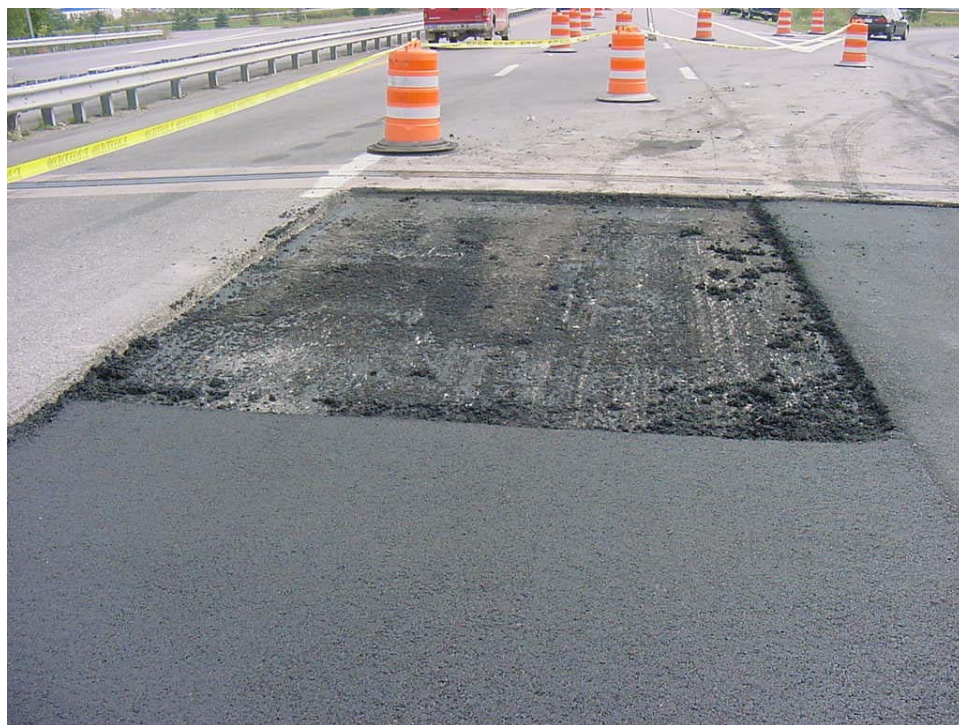
Paving continued into nightfall and darkness made it difficult to monitor construction. The contractor ran out of mix at the end of the travel lane and tried using header material to finish the mat. This mix was too cold to work with and tore during placement. By request of Royston, the mix was removed (Photo 13) and paved with hot mix the following day.

Photo 13. Removal of cold mix.

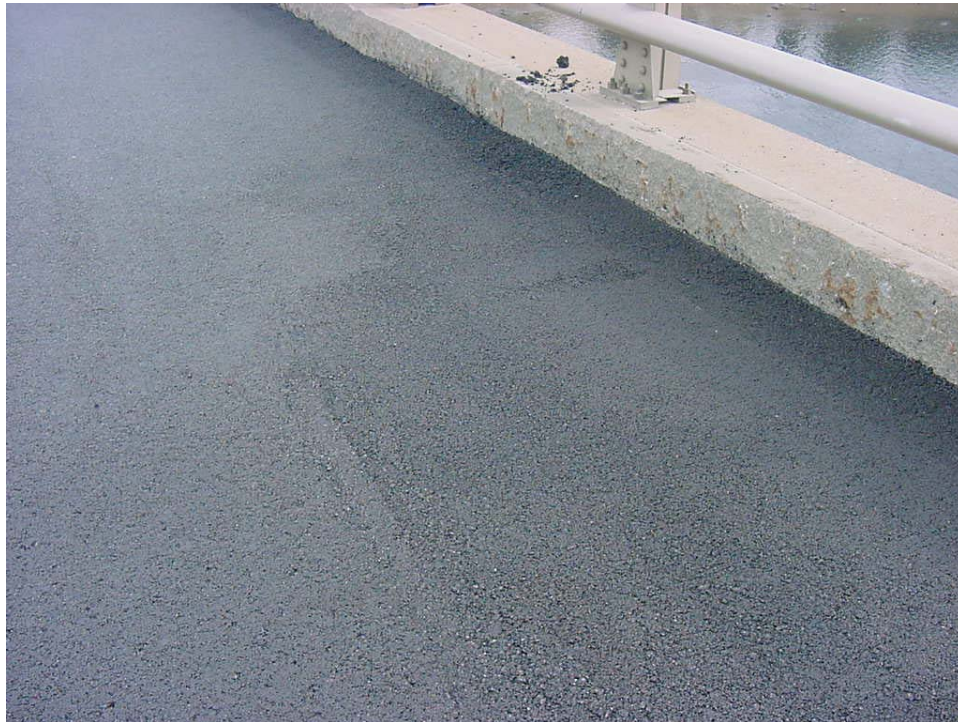
Areas along the granite curb, where the mat is tapered to compensate for the curved transition area of the bridge deck, appeared inadequately compacted (Photo 14).

Photo 14. Poorly compacted wedge area.
